**GeoNet**

**Preliminary Report on  
Landslides, Gully Erosion,  
and Debris Flood Effects in  
the Paekakariki Area as a  
Result of the 3 October  
2003 Flood**

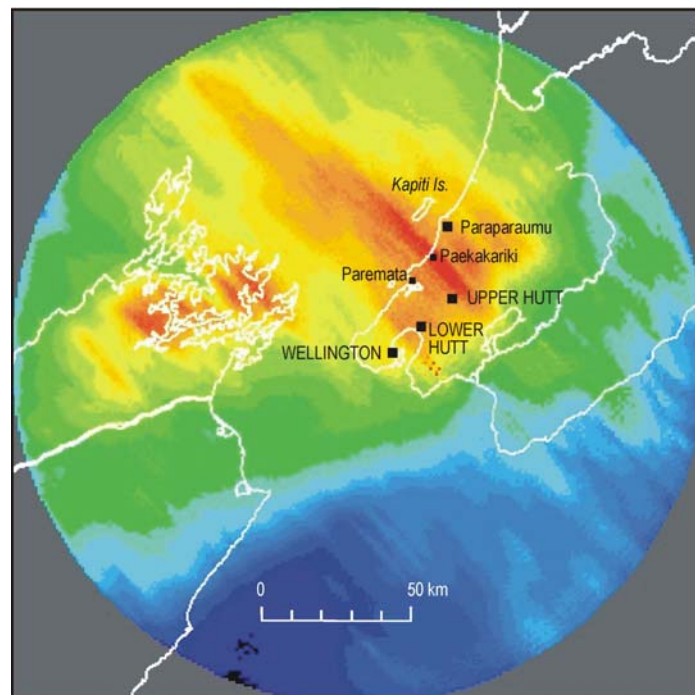
**Figure 1.** Radar-derived rainfall accumulation image for Friday 3 October 2003, showing total rainfall over the Wellington region for the period 6:45 am to 10:00 pm. Red is the heaviest rain and blue is the lightest. The band of heaviest rainfall coincides with the severe landsliding and flood damage observed in the Paekakariki area (*Image supplied by John Crouch, MetService*)

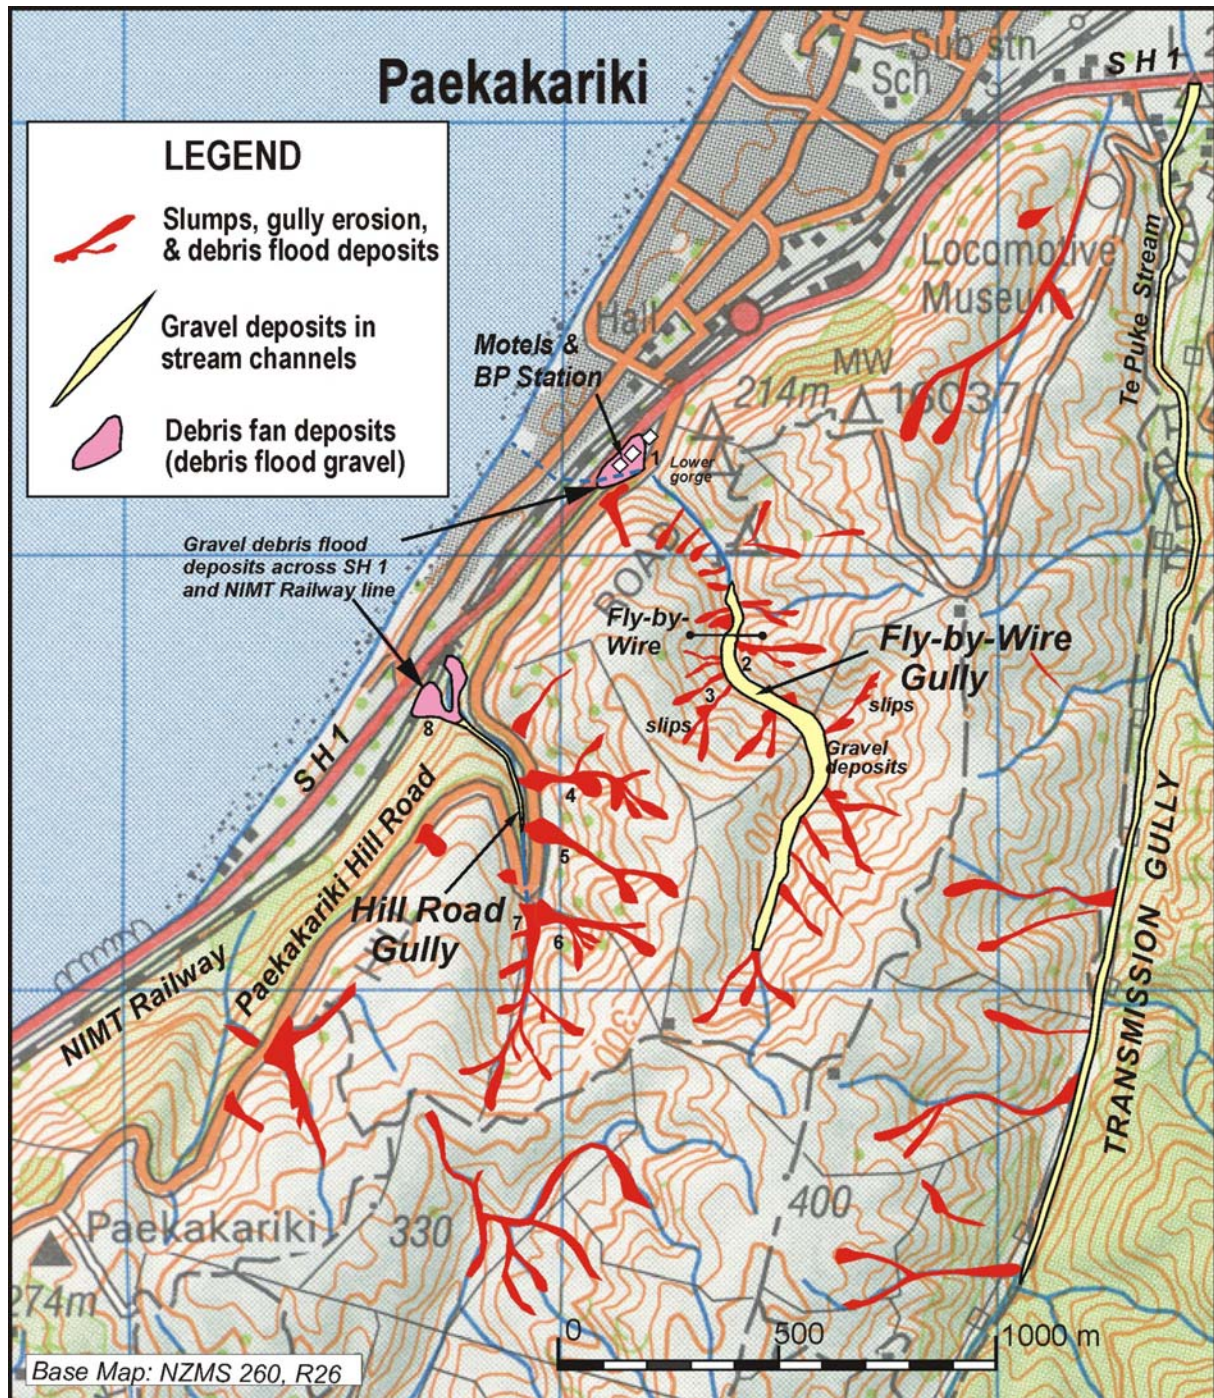
**Figure 2.** Map of the Paekakariki area showing the main landslides, gully erosion features and debris flood deposits resulting from the flood of 3 October 2003. Some of the main features and sites (numbered 1-8) are illustrated by photos and are discussed more fully in the report.

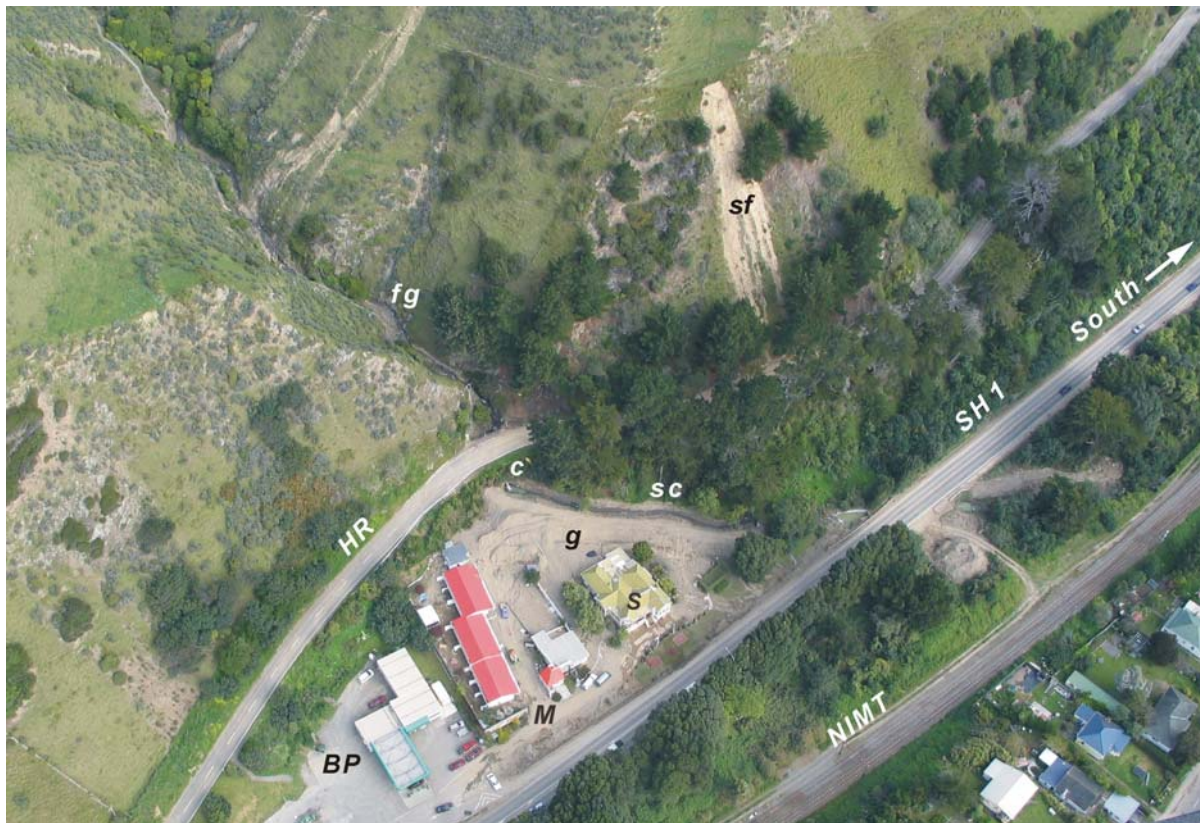
**Figure 4.** Aerial photo taken on Wednesday 8 October 2003 showing the gravel (*g*) from the Fly-by-Wire gully (*fg*) deposited around the Belvedere Motel (*M*) and Showroom (*S*, formerly the 1906 Restaurant) at the bottom of the Paekakariki Hill Road (*HR*), and across SH 1. A new stream channel (*sc*) was dug the day after the flood. The hill road and vegetation at the gully exit was unaffected by the flood, showing that all the debris passed through the culvert (*c*) below the road. The BP Service Station (*BP*) was flooded but was largely unaffected by gravel inundation. A small shallow soil flow slide (*sf*) spilled debris on to the hill road ~70 m south of the gully exit.

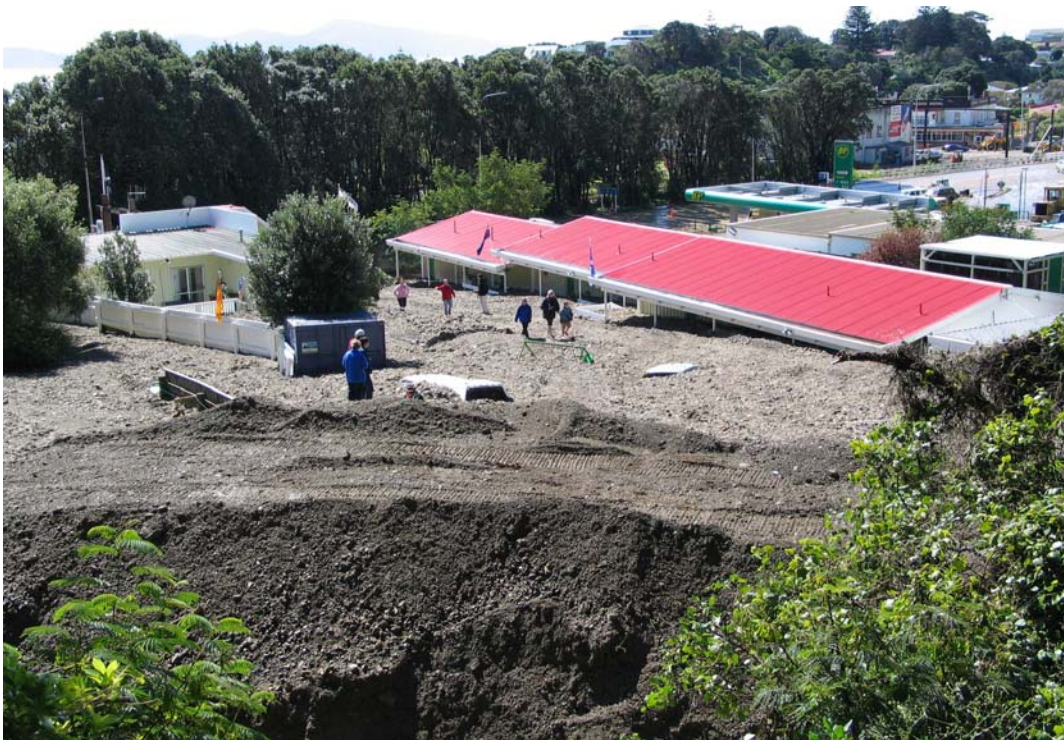
**Figure 5.** View of the debris flood gravel deposited around the Belvedere Motel and buried cars from the gully exit on the Paekakariki Hill Road. SH 1 is visible in the distance (top right).

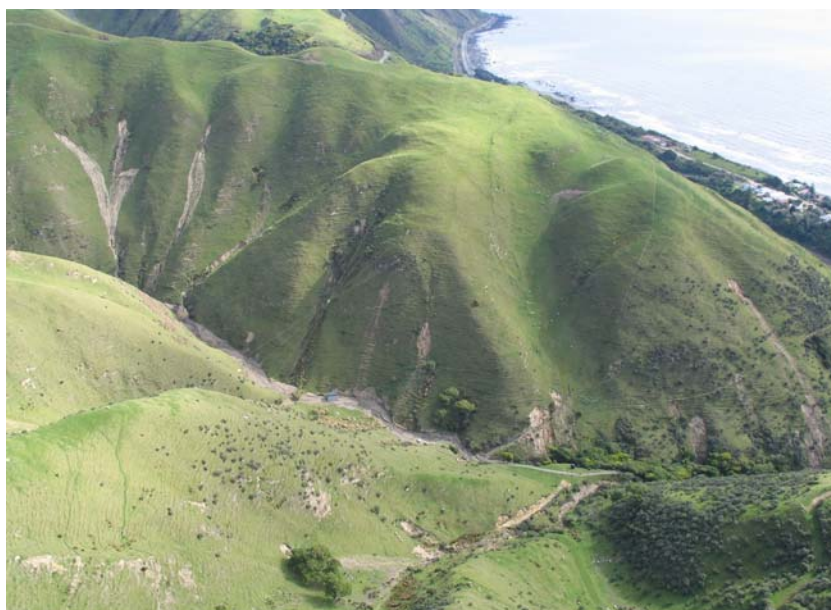
**Figure 10.** Aerial view of the lower section of the Fly-by-Wire gully looking south. The FBW hut is in the centre of the picture, with extensive gravel deposits in the stream channel both upstream and downstream. Large debris slides and flows can be seen on the upper slopes (top left, Site 3, Fig. 2), while smaller soil slumps and slides scar the sides of the lower gorge (bottom right). Most of the wooden walkways and bridges up the valley to the FBW site were destroyed by the flood.

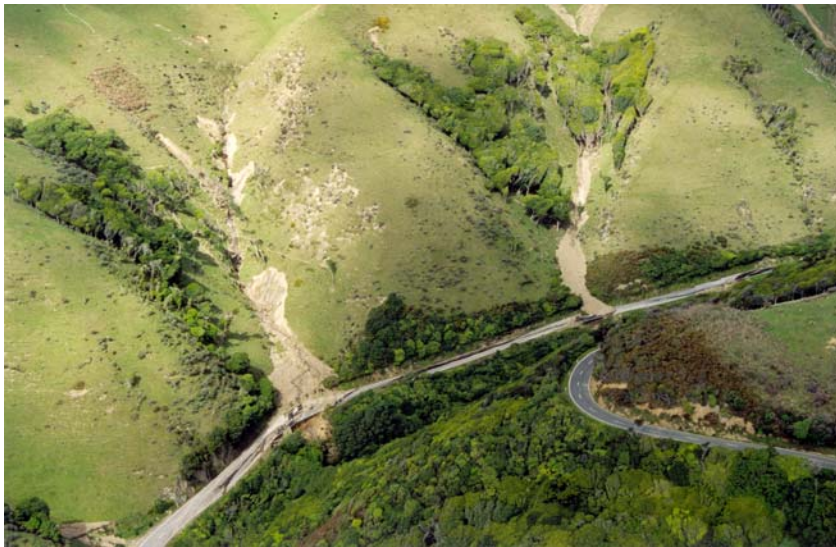
**Figure 11.** Aerial view of Sites 4 (left) and Site 5 (right) on the Paekakariki Hill Road (see Figure 2) showing the slips, gully erosion, and debris flood gravel deposits across the road, and undermining of the road due to fill wash-outs and collapses.

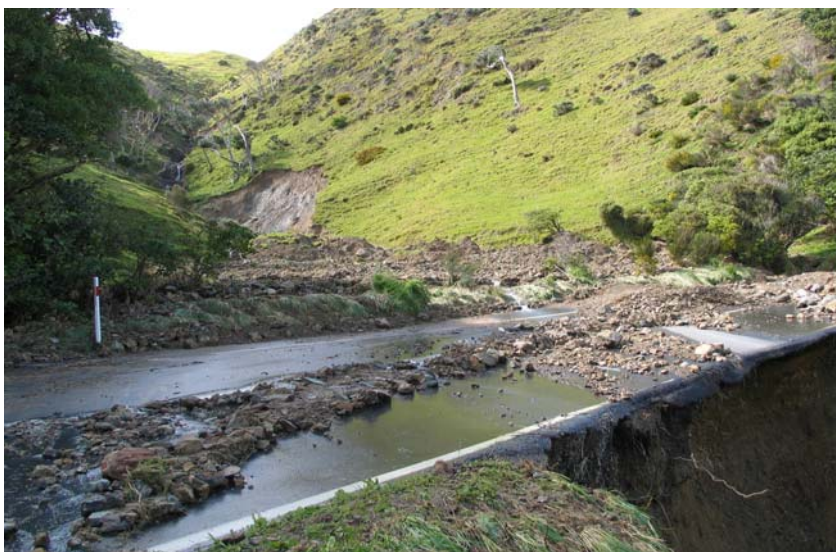
**Figure 12.** Ground view of damage Site 4 on the lower Paekakariki Hill Road, showing the soil slump and gravel debris deposited in the gully just above the road, where it has been trapped behind a farm fence. Some gravel was also washed across and down the road. Fill collapse has undermined the road edge here over a distance of about 10 m (the area in shadow bottom right).

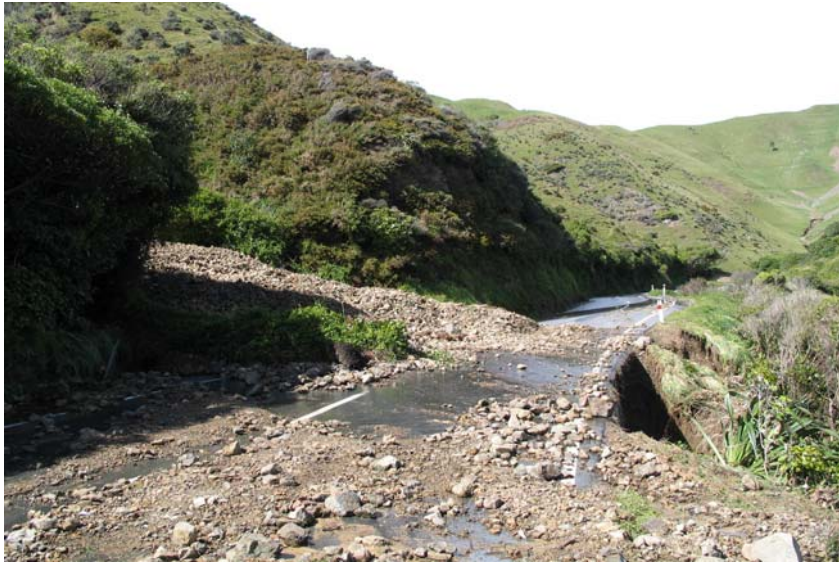
**Figure 13.** Damage Site 5 on the lower Paekakariki Hill road (see Figure 2), showing debris flood gravel from a small gully spilled across and down the road. The road edge fill has also collapsed and undermined the road.

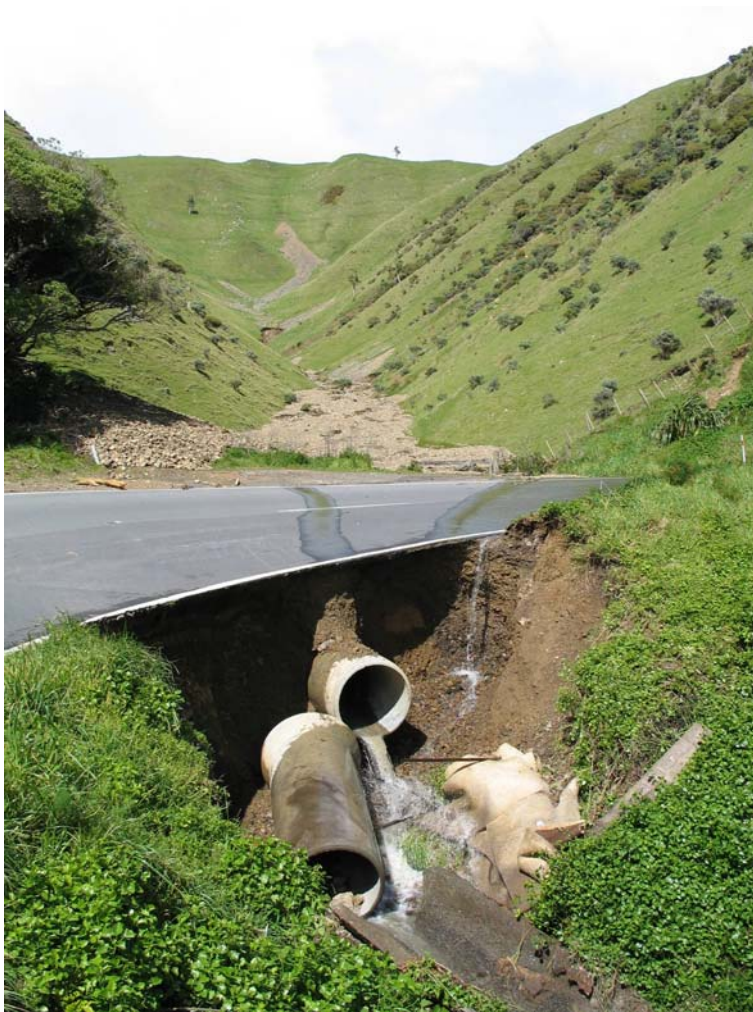
**Figure 14.** Damage Site 7 on the Paekakariki Hill Road (Site 6 is a debris lobe from the steep gully out of picture to the left – see Figure 16). At this site a large volume of gravel has been carried down from the head of the Hill Road Gully as a debris flood. However, here all of the gravel was trapped behind the fence and gate above the road (see Figure 15 also). Only flood water appears to have crossed the road at this location, washing out the road edge fill and undermining the road. No gravel debris has been carried across the road. The low volume of water flowing from the broken culvert pipe here is seeping through the gravel, which has completely blocked the culvert intake above the road.

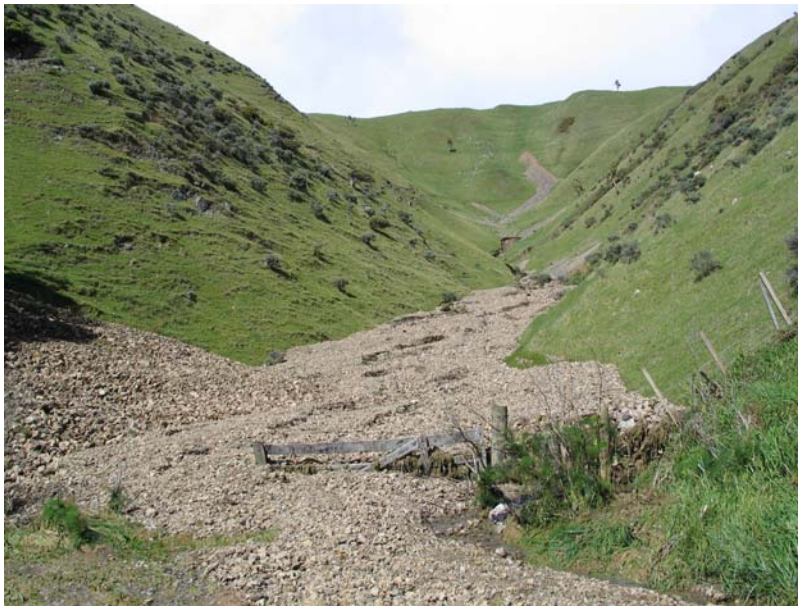
**Figure 15.** A closer view of Site 7 showing gravel trapped behind the fence and gate above the road. There was, however, little damage to the fence and gate, which suggests that the gravel accumulated slowly, from a hyper-concentrated debris flood of water laden with silt, sand, and gravel. Most of the finer sediment was carried away in the flood water. This type of mechanism shows that steel catch fences above the road could be used effectively to control future debris floods.

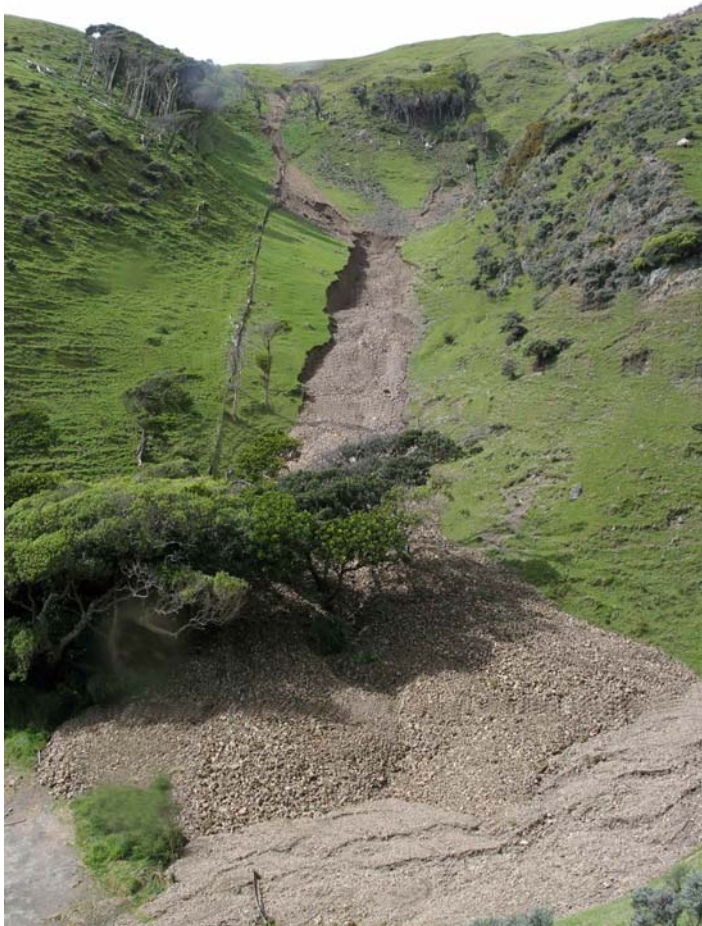
**Figure 16.** View of Site 7 on the Paekakariki Hill Road showing the deep erosion gully and large lobe of gravel debris formed at the bottom of a steep but normally dry gully. The lack of damage to trees inundated by gravel (lower left) suggests that this too was a debris flood event - not a debris flow. Note that the gravel debris lobe overlies material in the valley bottom, suggesting it was still forming after the flood in the main gully at the bottom had declined. This very deep erosion gully and large debris lobe is another example of the type of ground damage that suggests that the flood was a very rare event, as no old or 'fossil' features of a similar nature are visible in the present landscape in the area.

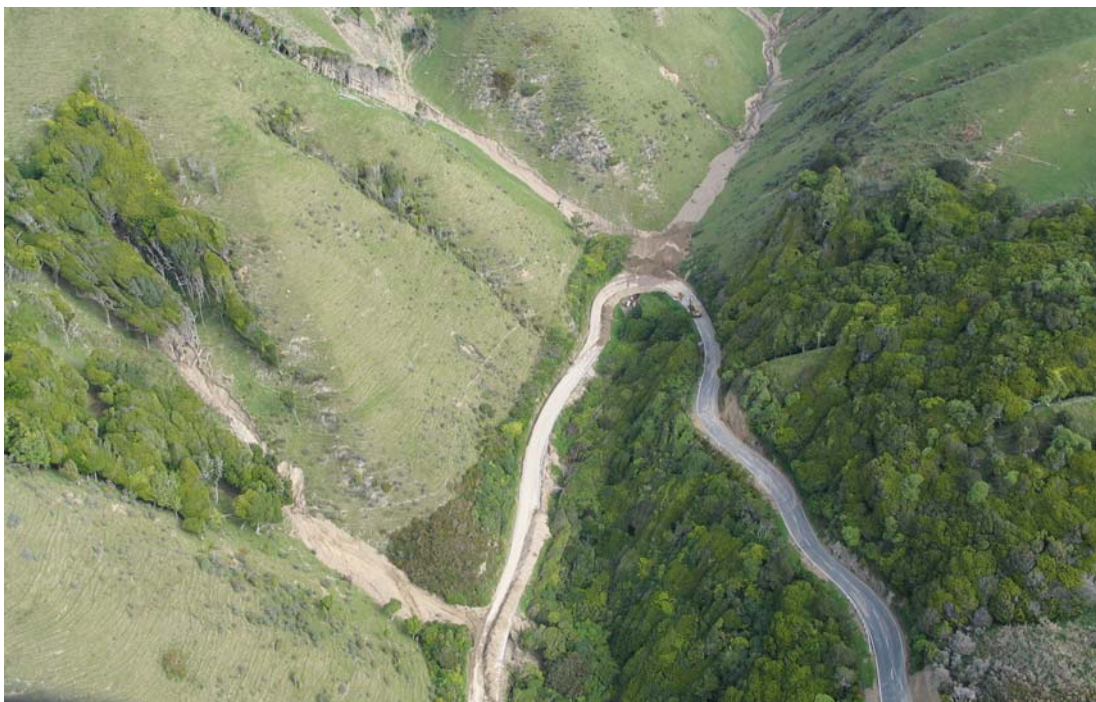
**Figure 17.** Aerial view of damage Sites 5 (left) and 6/7 (top) on the lower Paekakariki Hill Road on Wednesday 8 October after remedial work had begun. It shows two gullies where debris control fences could be effective in preventing, or at least reducing such damage in the future.

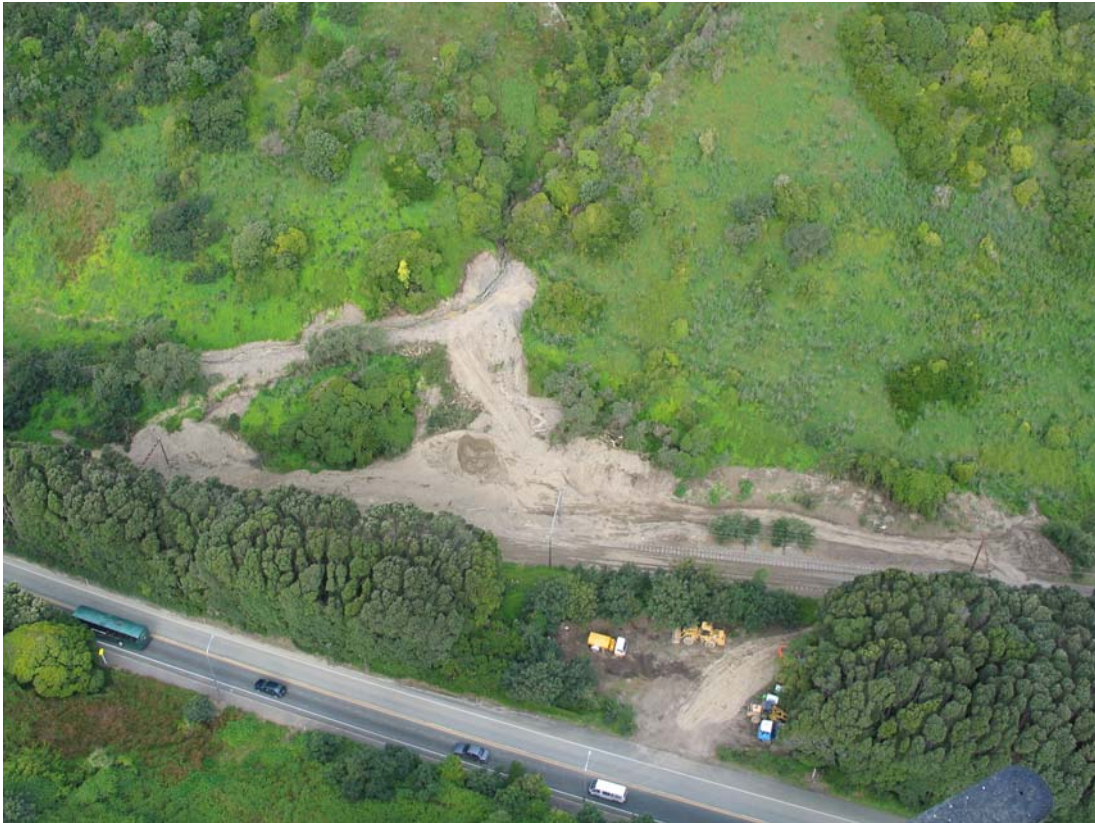
**Figure 18.** Aerial view of damage at Sites 8 at the bottom of the ‘Hill Road Gully’ on Wednesday 8 October showing the large volume of gravel, sand and silt that spilled across the NIMT railway line during the 3 October flood. Control of debris higher up this gully would minimise problems at this site. Some form of debris passing structure may also be necessary at the culvert entrance to prevent blockages and allow flood water to be safely passed under the railway and SH 1.
