Friends Of Paekakariki Streams

Wainui Catchment

Status Report

by Paul Hughes

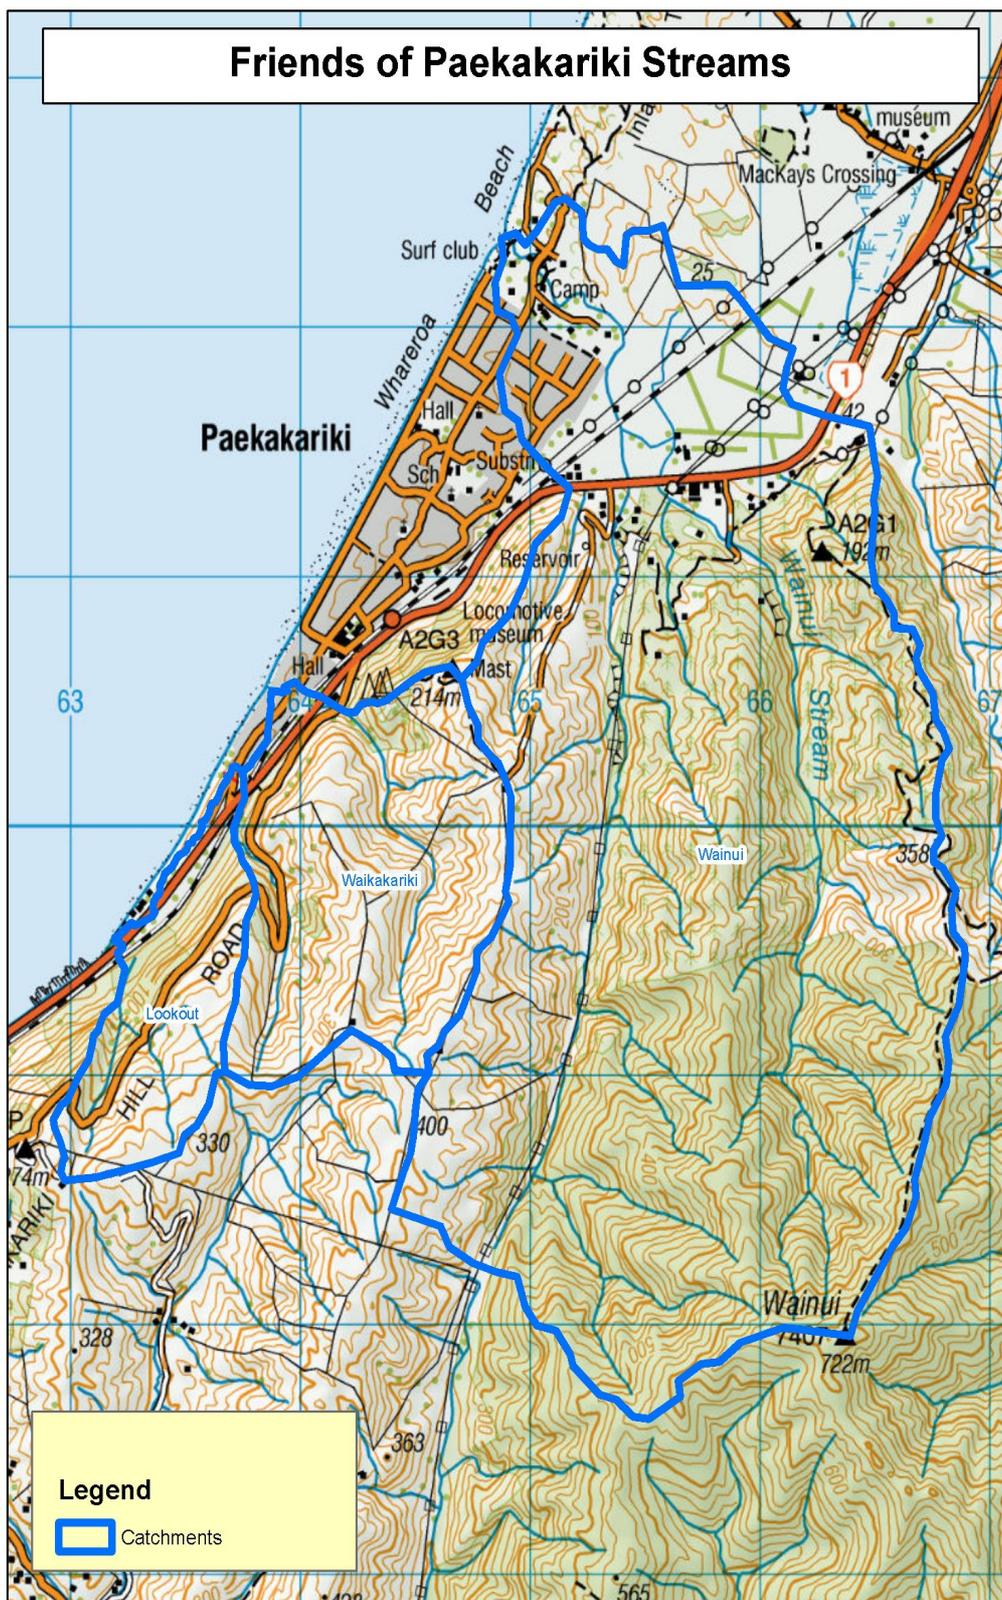
Figure 1: Paekakariki catchments

It is one of three catchments in Paekakariki. The Waikakariki Stream drains under Paekakariki Hill Road, past the motels, and under Ames St, entering the sea south of Beach Road. The Lookout catchment is rather dry, entering the sea south of the Fishermans Table restaurant.

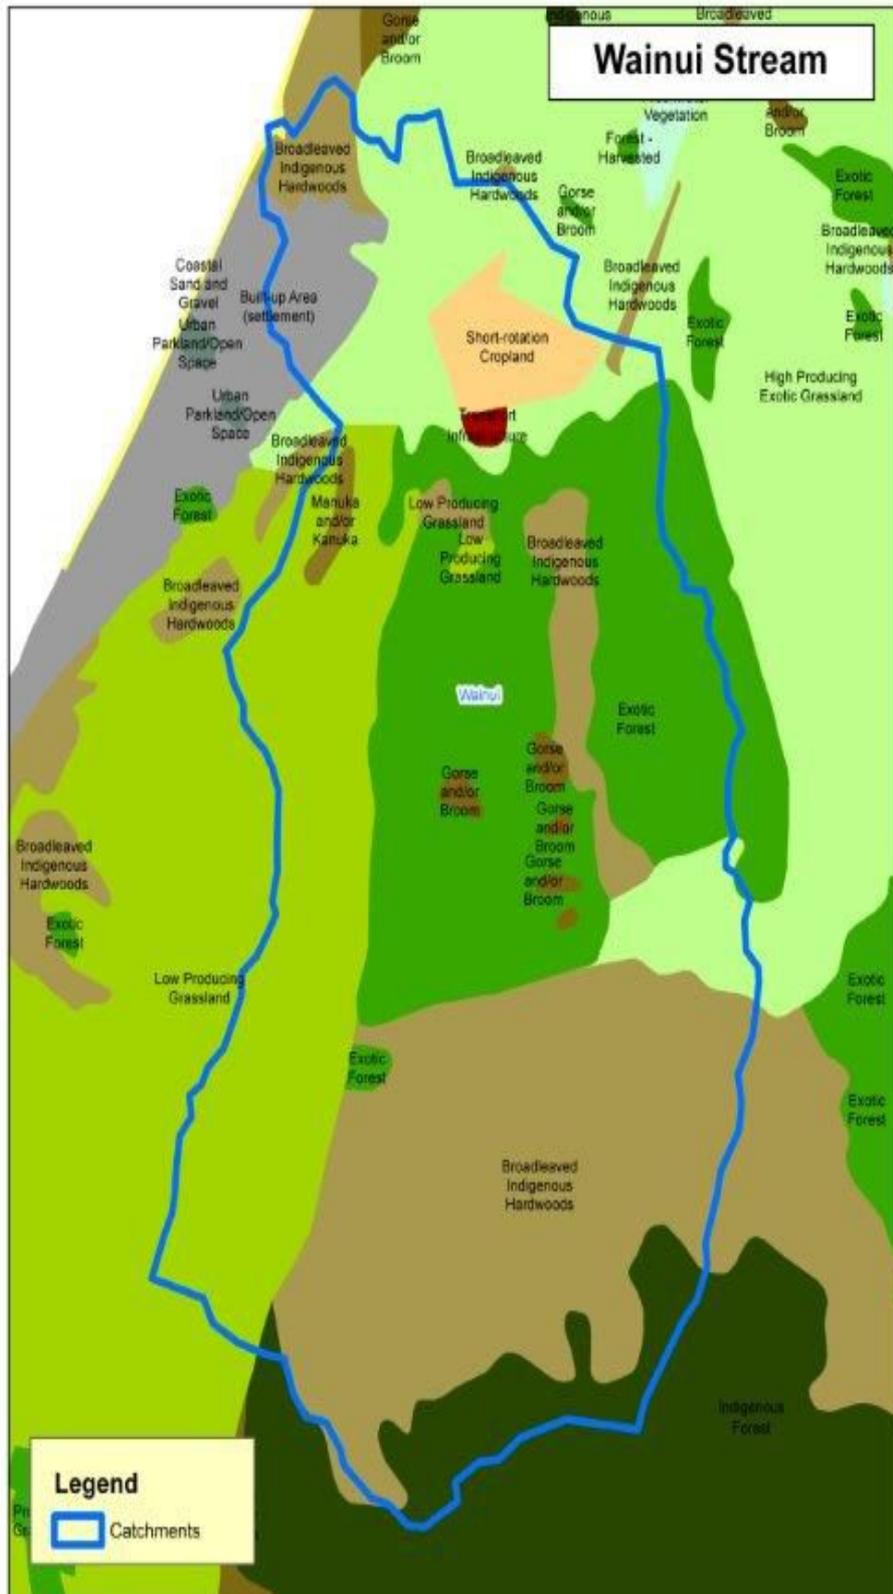
Figure 2: Landcover in the Wainui catchment(from LandCover DataBase V3)

Landcover comprises primarily native forest, pasture, and exotic forest:

Landcover	Catchment percentage
Native forest	37
Grassland	30
Exotic forest	26
Cropland	3
Residential	3
Scrubland	1

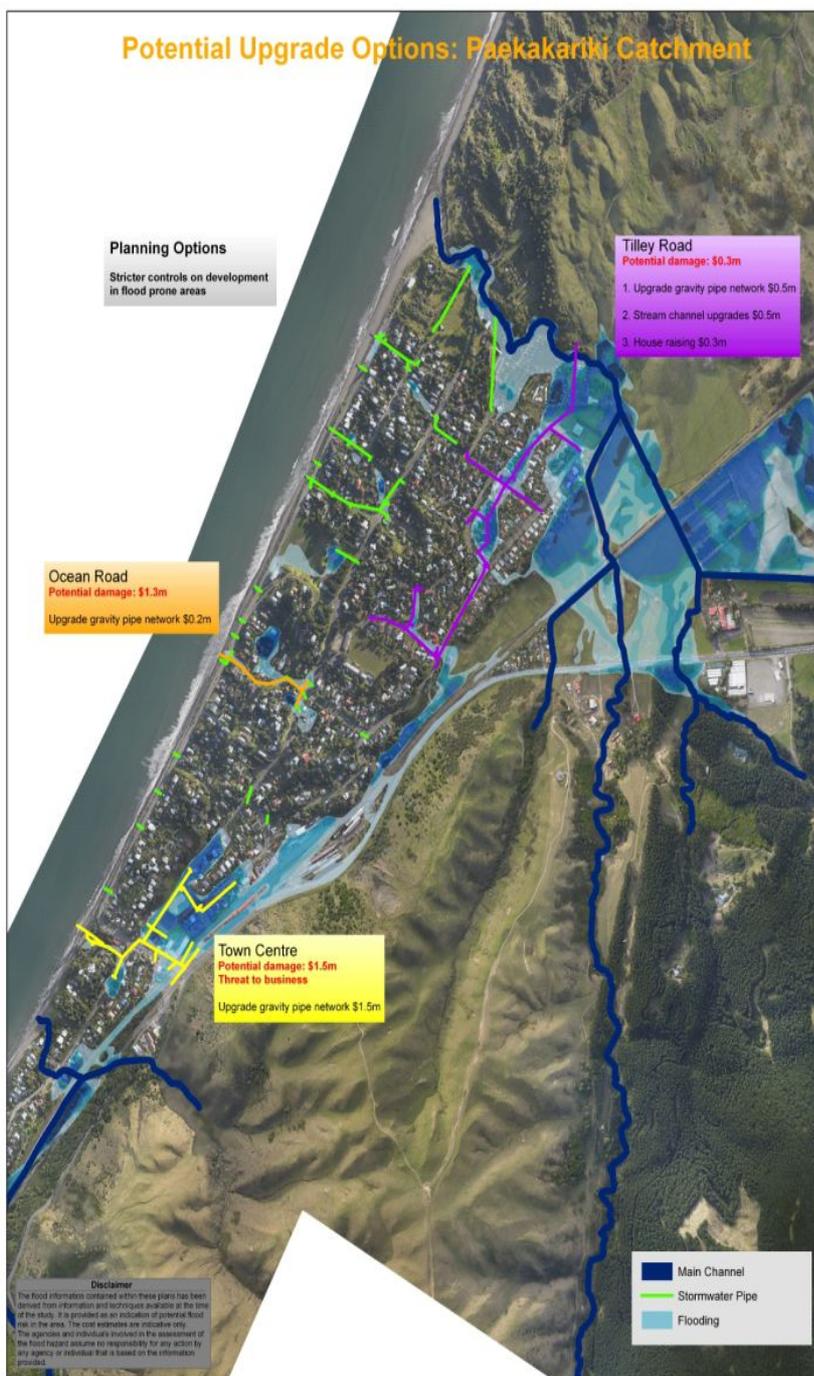
Figure 3: Paekakariki catchment map (KCDC 2012a)

Much of the lower Wainui Stream catchment is prone to flooding as the flows from the hill country start to spread out dropping sediment, and then meander through the dune belt to the sea. State Highway 1 and the railway line form artificial barriers that encourage surface ponding.

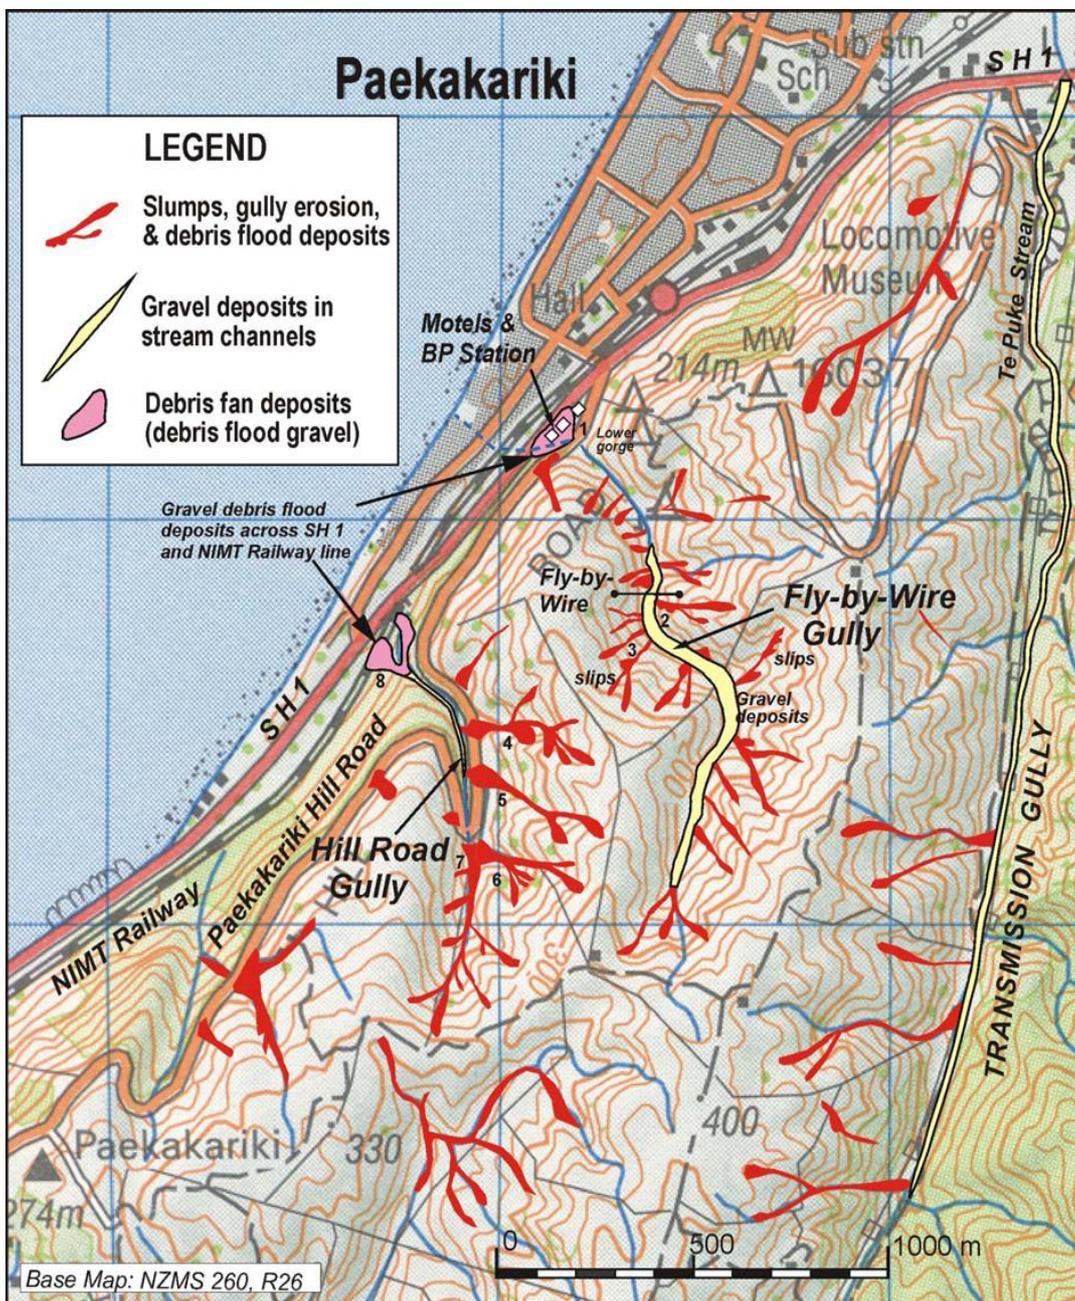
Figure 4: Sediment sources originating in 2003(GNS 2003)

The flooding risks are from surface runoff and sediment that is carried by them that creates “debris floods” and chokes up streambeds. The runoff is a particular problem when high intensity rainfall events arrive from the north or northwest as the terrain in the upper catchment faces these weathers. Floods are exacerbated if there has been a dry period beforehand, which is often a problem with the denuded farmland that exists at present. This farmland contains slumps and gully erosion that are generating significant sediment in the Te Puka Stream subcatchments.
