Paekākāriki Lake Hollow Flood Protection

May 18 2017

By Paul Hughes

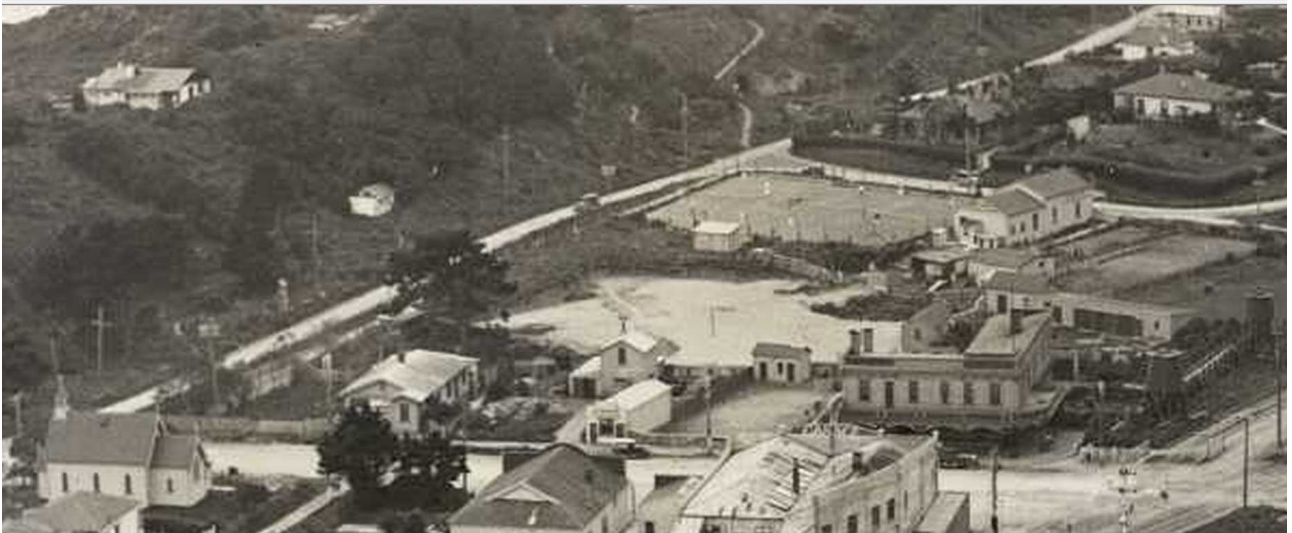
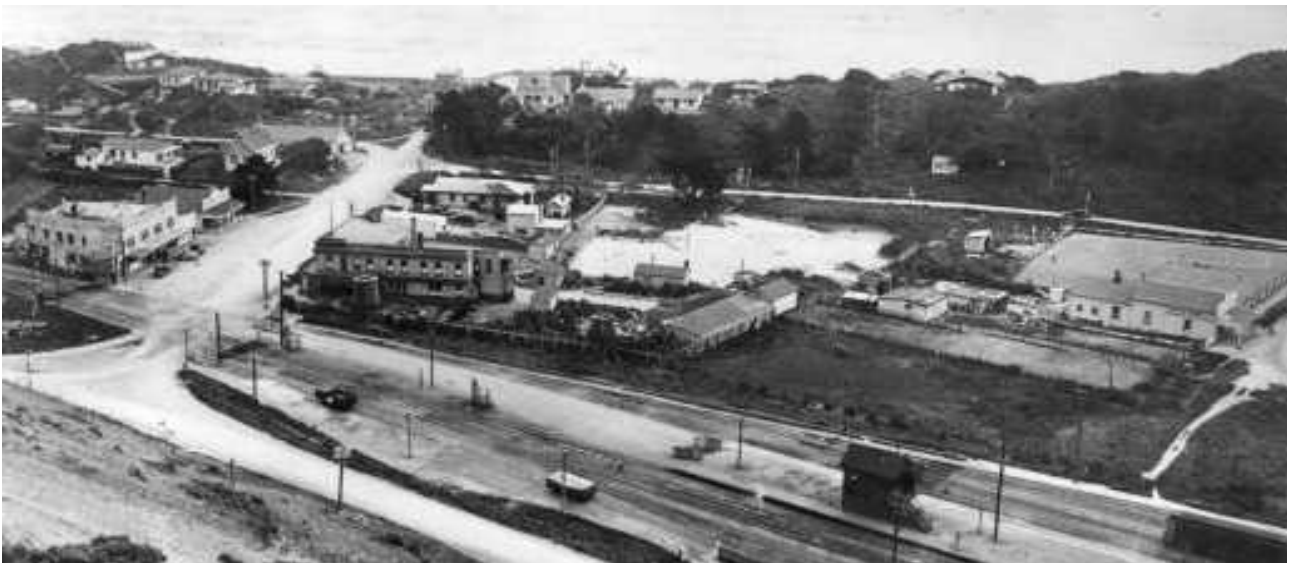
From the south

From the east

1929 – remains of the lake between Wellington Road, tennis courts and the Post Office.

This lake has since been drained by a stormwater pipe to the beach south of Beach Rd, but this drain has limited capacity to clear flooding.

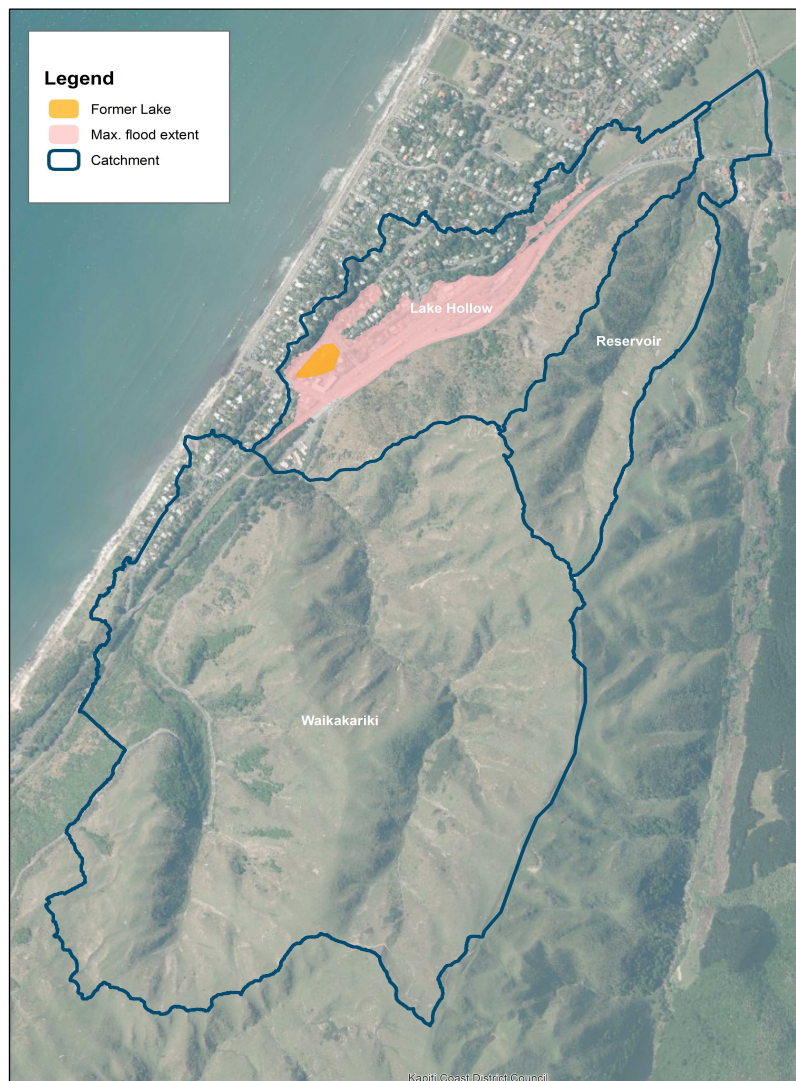
Lake Hollow and adjoining overflowing catchments

Council have modelled high rainfall events and established that a one in one hundred year rainstorm will flood Lake Hollow, particularly from neighbouring catchments overflowing into the Lake Hollow catchment.

In the north, the Reservoir catchment high flows are caught by the camber of State Highway 1 and are directed south along SH1 and into Lake Hollow.

In the south, the Waikakariki catchment high flows are directed north into Lake Hollow by two means; Overflow at the railway line culvert, or debris overflow beside the Belvedere Motel.

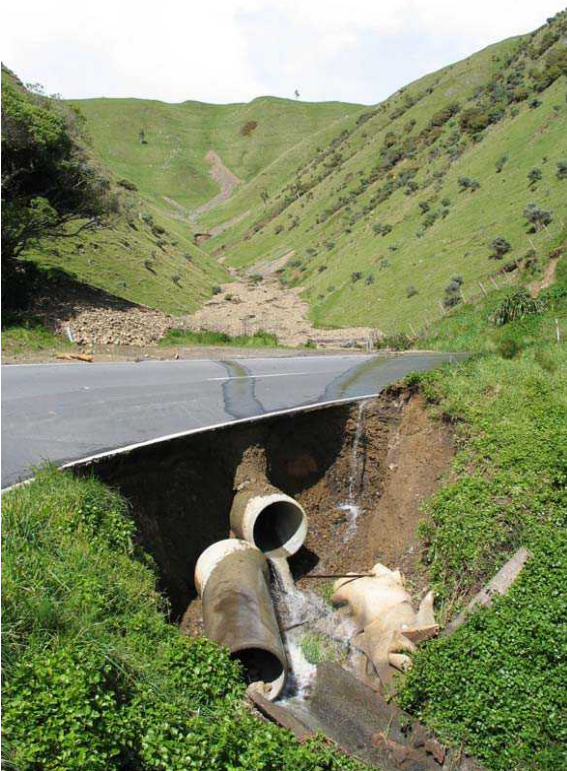
Council's Paekākāriki Hill Rd was severely impacted

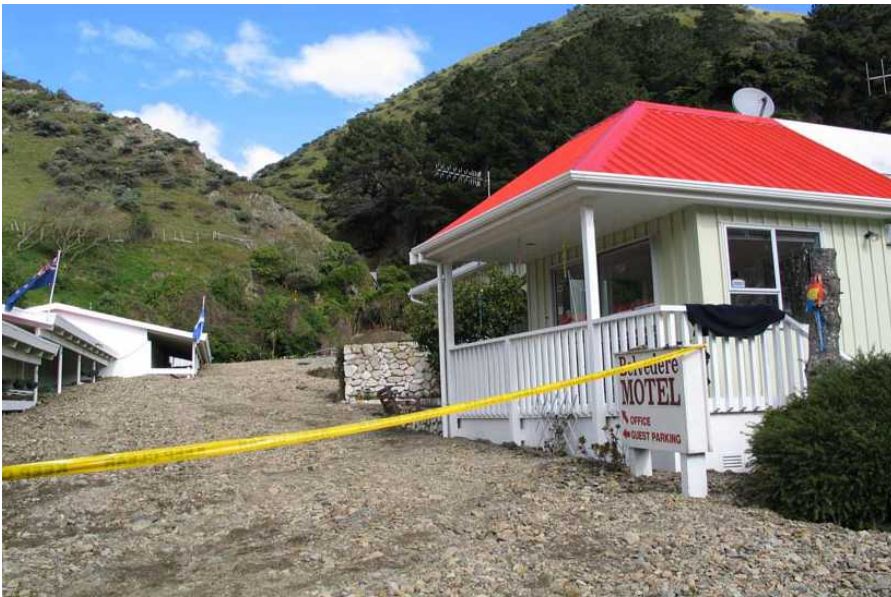
Debris flood through motel

It flowed through the Belvedere Motel area.

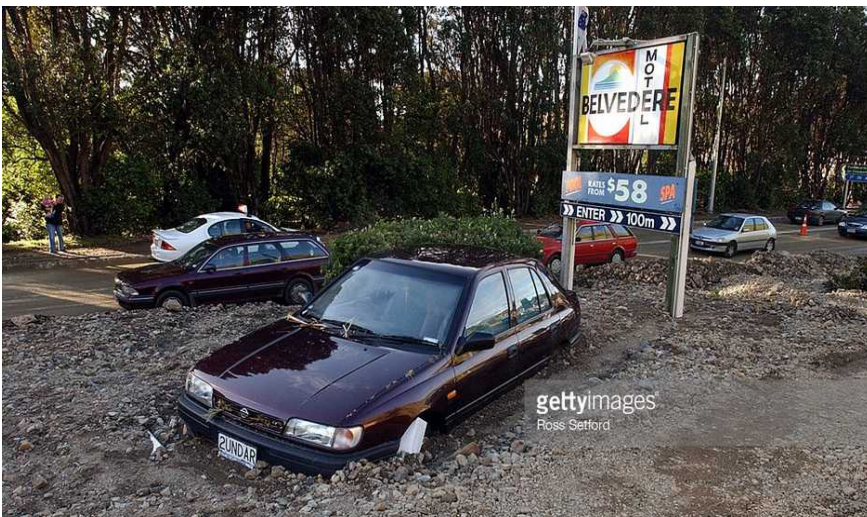
Burying cars

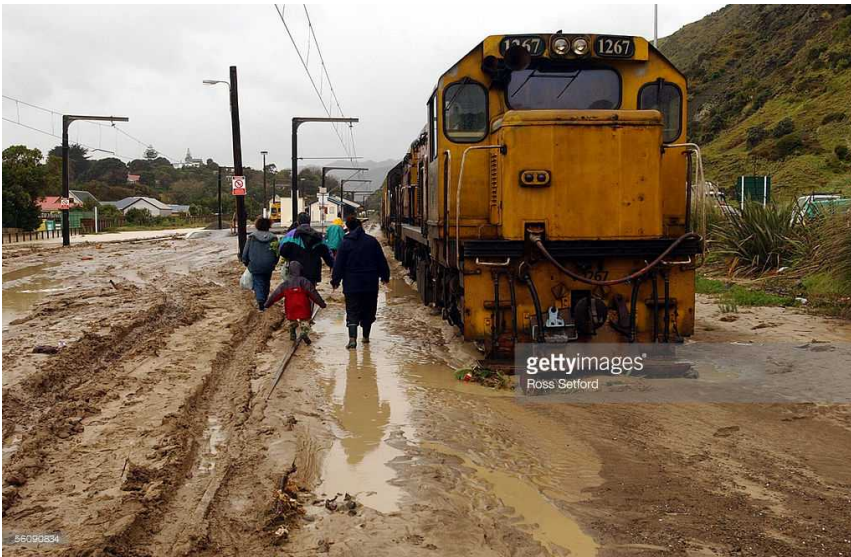
Blocking trains

It progressed through the railway crossing area.

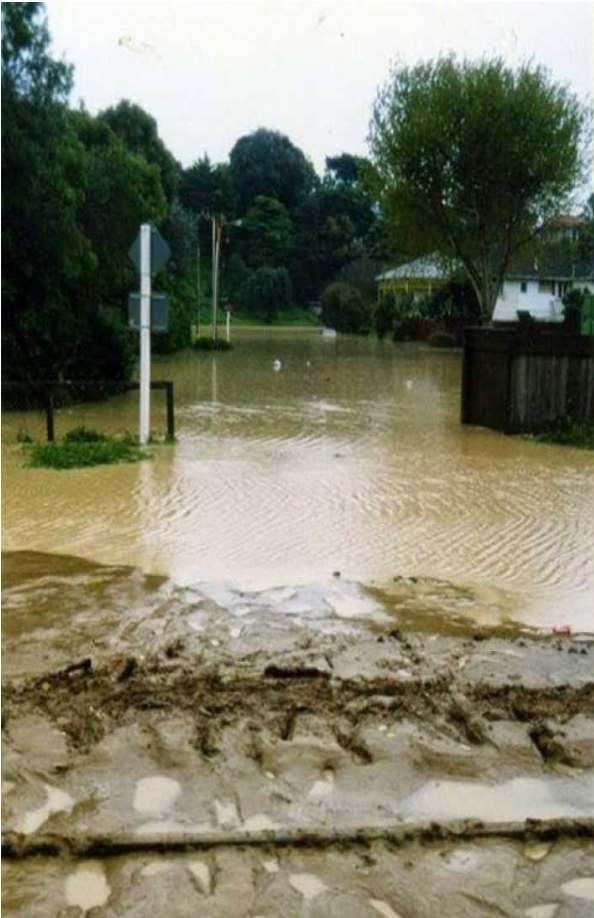
Robertson Rd houses flooded
